**HYDROGEOLOGICAL INVESTIGATION OF  
EARTHQUAKE RELATED SPRINGS  
IN THE HILLSBOROUGH VALLEY  
CHRISTCHURCH, NEW ZEALAND**

A thesis  
submitted in partial fulfilment  
of the requirements for the Degree of  
Master of Science in Geology  
in the  
University of Canterbury  
by  
Mitchell James Green

University of Canterbury  
2015

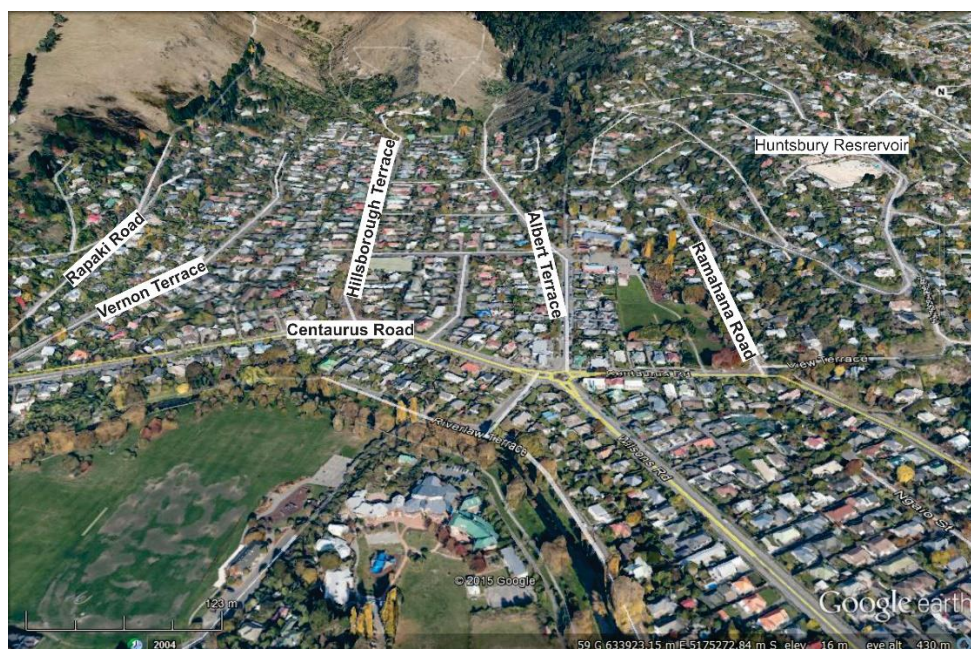
**Figure 1.2: Oblique view of the Hillsborough Valley looking south showing the extent of residential development, roads and the Huntsbury Reservoir on the western slope of the valley. (Google Earth 2015)**

This thesis study focuses on the formation of earthquake-related springs in the areas surrounding the base of the Port Hills, and specifically in the Hillsborough Valley (Figure 1.2). The 0.9km<sup>2</sup> Hillsborough Valley is located on the northeast of the Port Hills, and is flanked by the loess-covered Lyttleton basaltic lava flow packages that form the Huntsbury and Murray-Aynsley hills (Ogilvie 2009). It is a predominantly residential area of Christchurch, with development of both the valley floor and upwards on the valley slopes, although it was originally a mostly horticultural area of early Christchurch (Wilson 2005). The Hillsborough Valley is also referred to as the St. Martins Valley by others, as in Ogilvie (2009). Springs and seepages emerged within the valley in previously dry areas along and adjacent to footslope positions within 24 hours following the Darfield 2010 earthquake, with the number and magnitude of springs greatly increasing following the February 2011 Christchurch earthquake. The spring features have flowed persistently since their initial appearance, and continued to flow throughout this study.

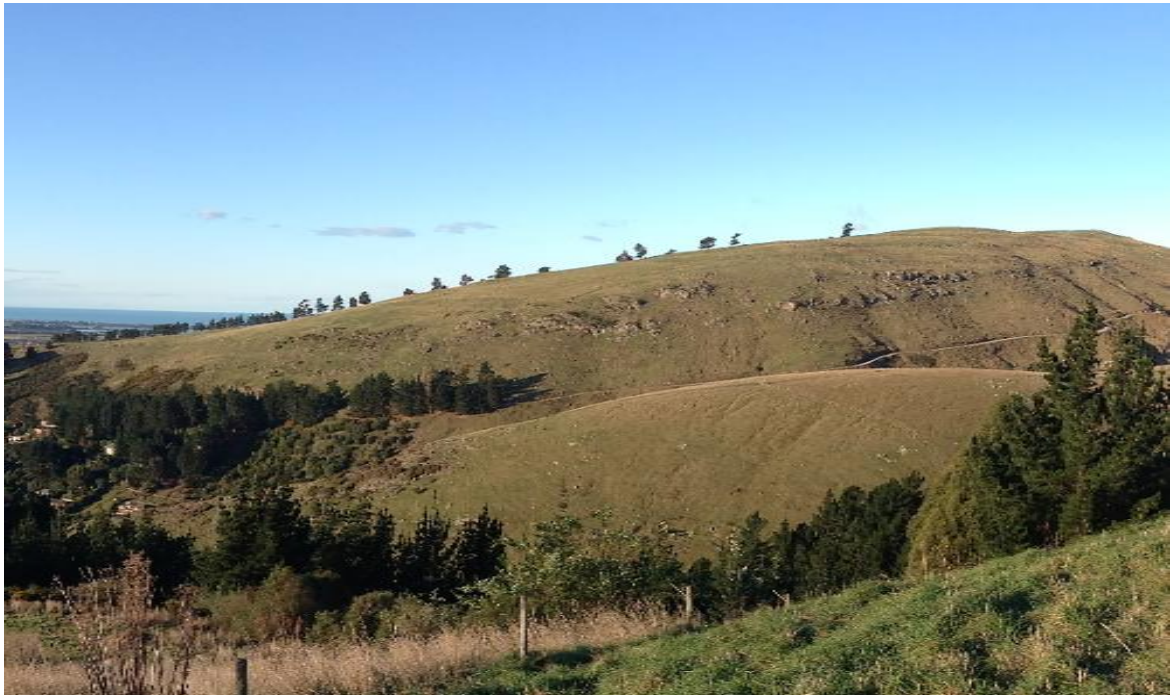
**Figure 3.3: Lava flows outcropping along the Rapaki Spur, image is oriented to the east.**

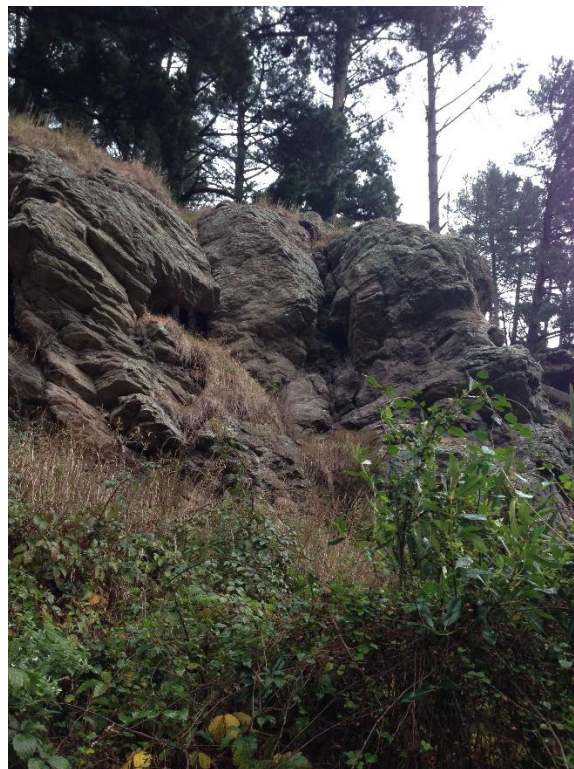
Figure 3.5: Hawaiite flow exposed at the entrance to the Mt. Vernon gorge, Note the irregular and platy cooling joints and fractures.
